January 7, 2026

City of Portsmouth Tree Assessment

Portsmouth, NH City Hall
1 Junkins Ave,
Portsmouth, NH 03801

Timothy Bergquist
TimBer Property Consulting LLC
199 Holland Street
Moultonborough, NH 03254
(603)476-7118

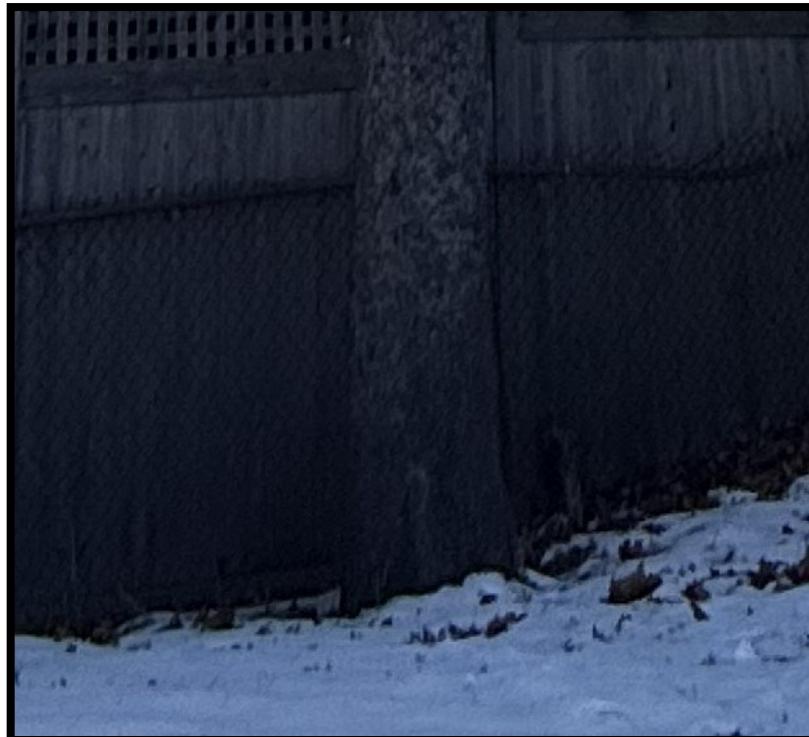
As I approached the tree, I inspected the trunk and root flare of the tree. The tree had a healthy taper at the base of the trunk (Photo 4), and I could see no indications of fungal decay or lifting of the root plate. During inspection of the trunk of the tree, I did not observe any indication of decay, insect activity, or structural issues (Photos 5 and 6). The subject tree had a straight and upright **excurrent** growth pattern with no lean to the trunk or crown of the tree.

Photo 4: A view of the trunk, and root flare, there is not indications of insect or disease activity, the root plate is not lifted due to wind damage.

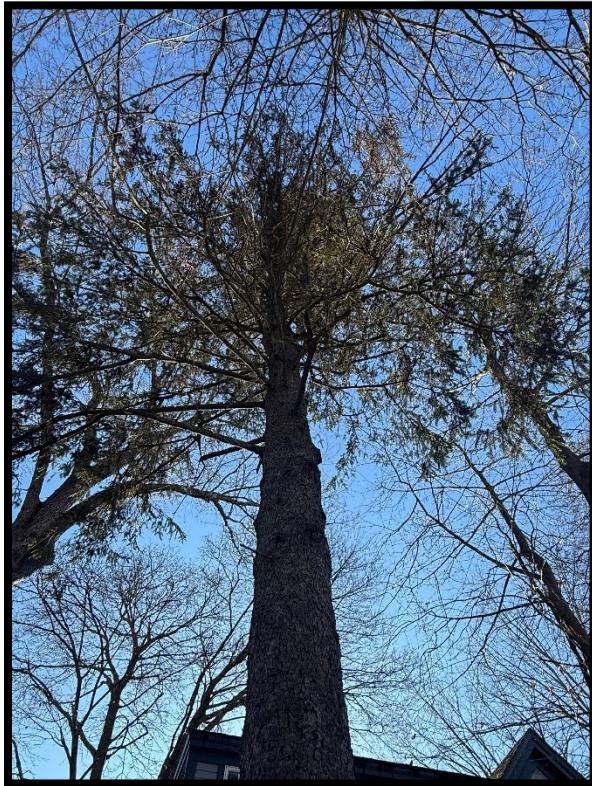
There are some small dead branches on the lowest interior portion of the crown, which are near the encroaching maple branches (Photos 5 and 6). I observed that the tree had a crotch between two leaders, approximately 30 feet from the ground (Photo 7)

Photo 5: This photo was taken of the North side of the trunk, I could see no insect or disease activity.

- Prune the deadwood 2" or larger to protect damage to a nearby vehicle, and the fence located beneath the tree.
- Have a qualified arborist inspect the junction between the two leaders for any signs of structural damage or decay.
- Have the tree inspected by a qualified arborist regularly, I recommend every 2 years, and after a major weather event such as a major storm or drought.

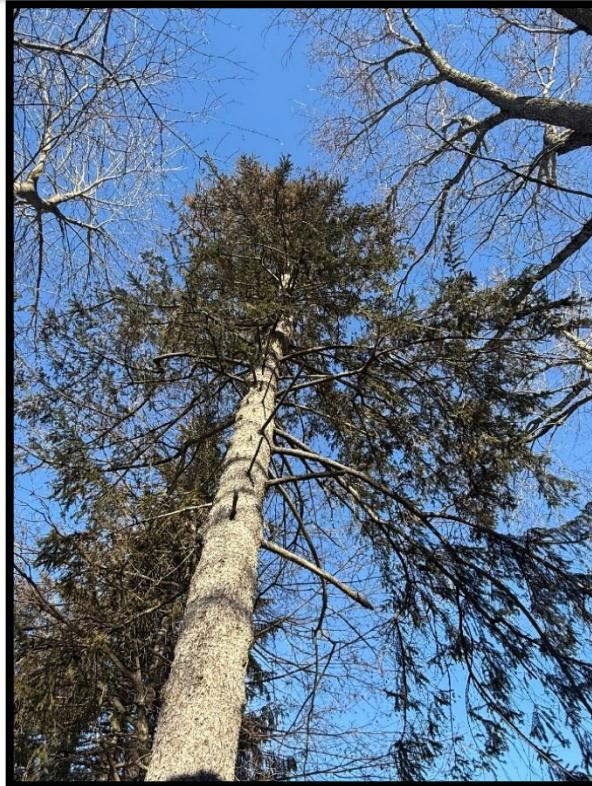
Photo 6: This photo was taken of the Southwest side of the trunk, there is no indications of insect or disease activity.

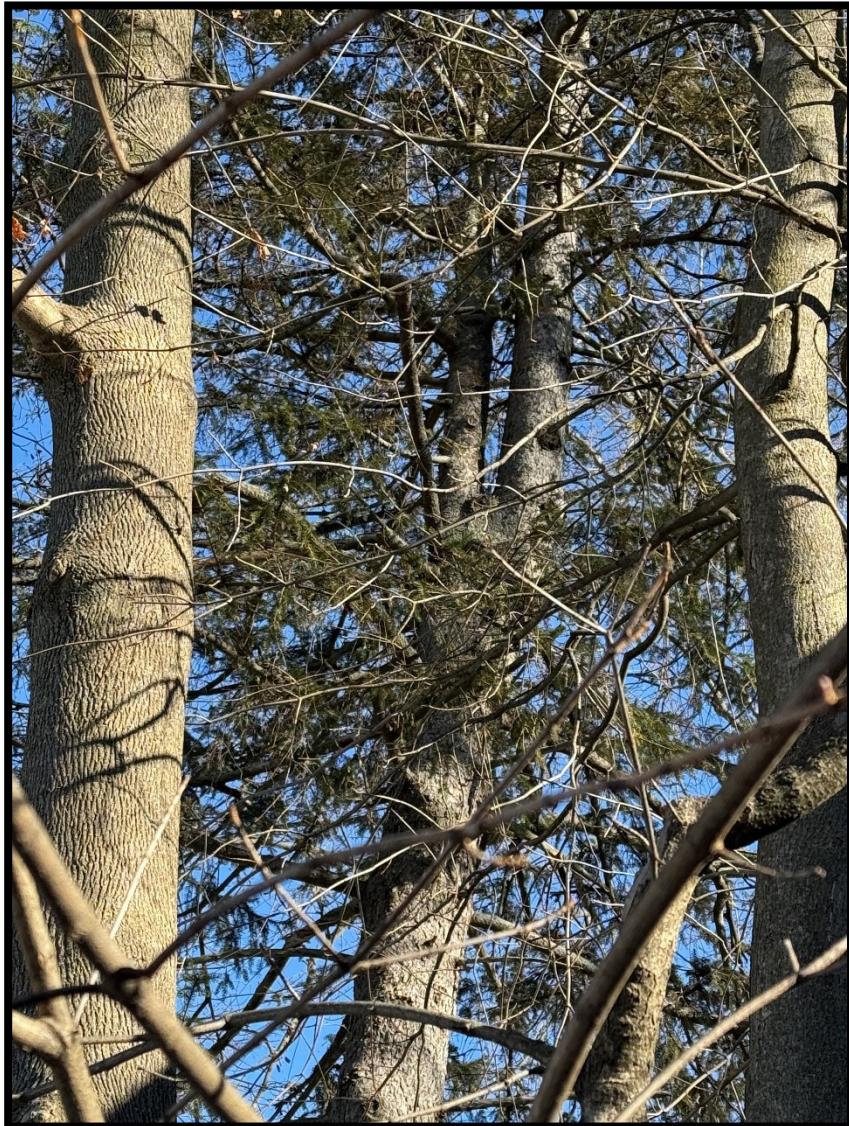
Photo 7 shows the crotch between the two leaders; the leader to the right is dominant and continues to the top of the tree. The leader to the left is smaller and ends approximately 20 feet above the crotch between the leaders. I can see that there is no **included bark** between the leaders, or indications of damage or decay. There is a small **overextended branch** near the top of the secondary leader, and the Norway maple that is located on the left side of the tree in Photo 3.

Photo 7: A close view of the subject tree where the trunk divides in to two leaders.

I performed a thorough inspection of the subject tree during my site visit and could find no major health or safety concerns. The tree appears to be in fair condition and has a couple of minor structural issues. The division between the two upper leaders is one of the minor structural issues; I did not observe any included bark. This indicates that there is a strong connection between the leaders, which is less likely to fail under extreme weather conditions than one with included bark between the leaders. The second issue is an overextended branch located near the top of the secondary leader. Branches with these issues are more susceptible to failure during wind events; this issue on the subject tree can easily be rectified with pruning.

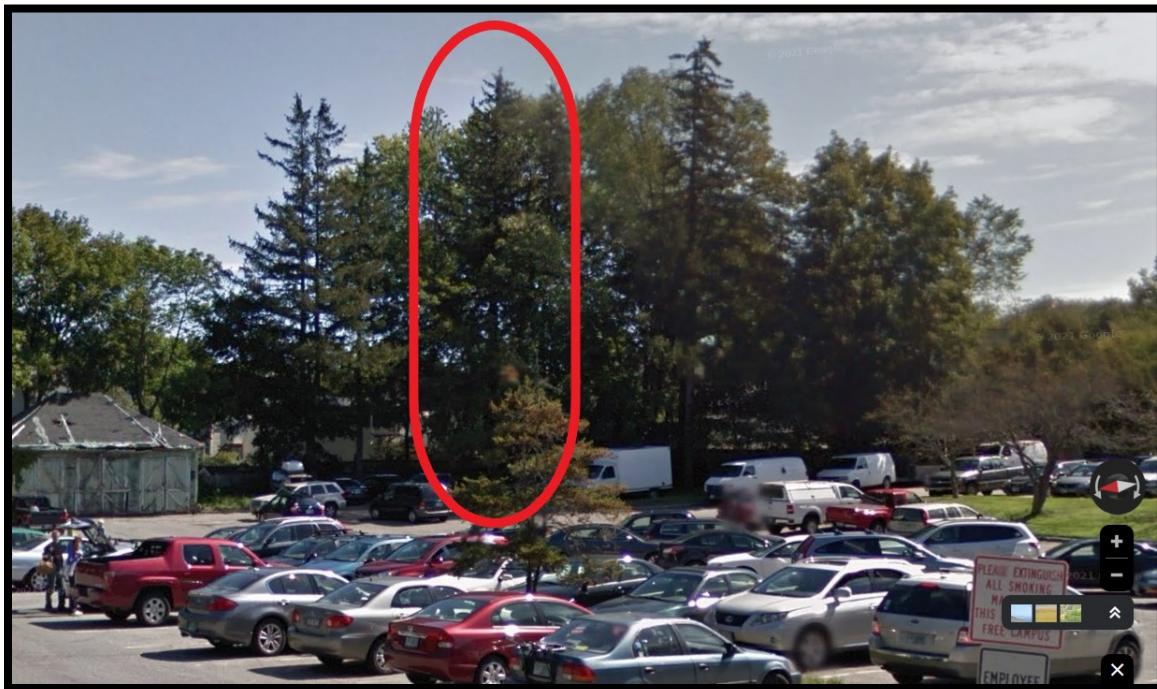
I used Google Street View to observe the subject trees' condition over time. Photo 8 was taken in 2011; the tree appears healthy with a fairly full crown. There is another Norway spruce on the right side of the tree; it appears to be in fairly good condition. Photo 9 was taken in 2017, and it shows little change in the subject tree's condition. The Norway spruce on the right side of the subject tree appears to be stressed, with a thinner canopy than in the 2011 photo. Photo 10 was taken in 2019, and it also shows little change in the subject tree's condition. The Norway spruce on the right is dead in this photo. Photo 11 was taken in 2024, and it also shows little change in the subject tree's condition. The Norway spruce to the right has since been removed.

Photo 8: A 2011 Google Street View of the subject tree which is circled with red. The evergreen tree to the right of the subject tree is also a Norway Spruce, it looks healthy in this photo.

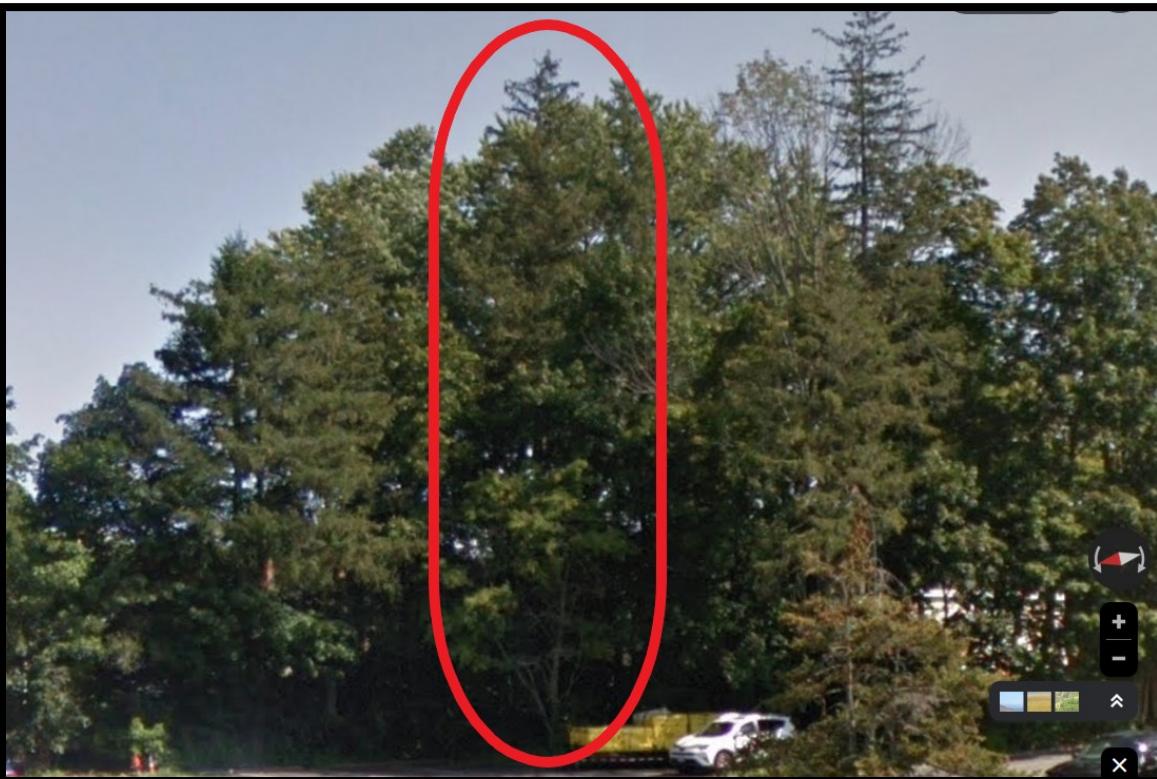
Photo 9: A 2017 Google Street View of the subject tree circled in red. The Norway spruce located on the right side of the subject tree is showing indications of stress.

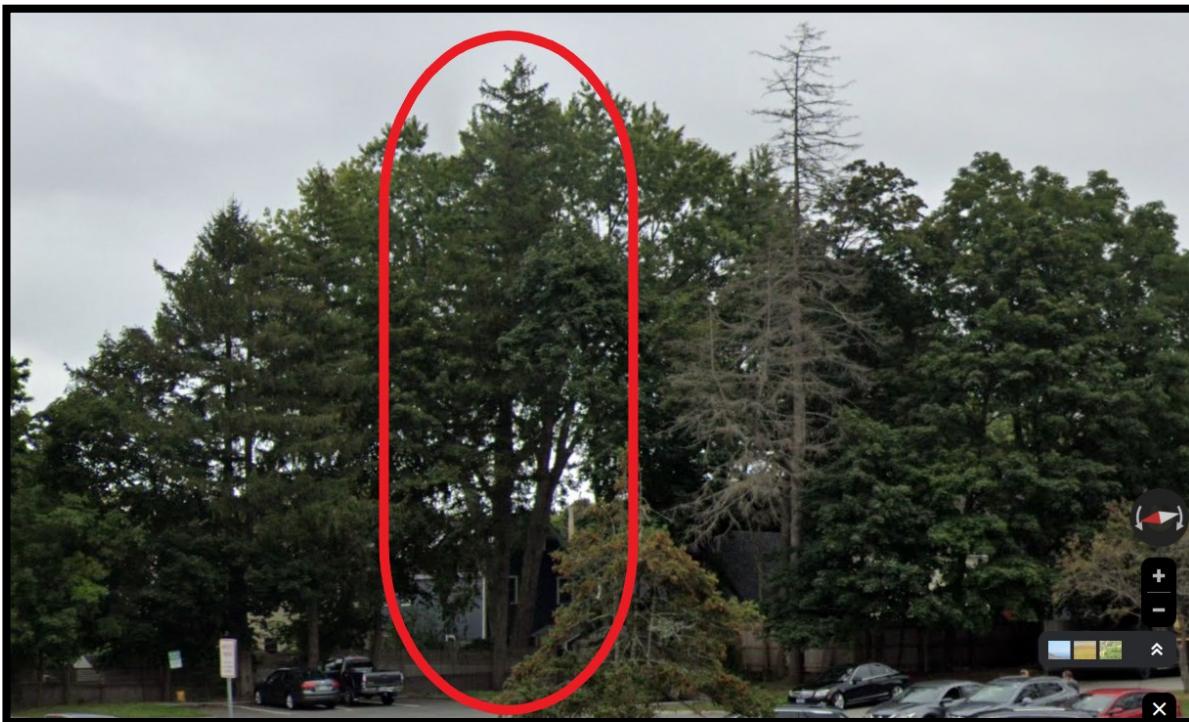
Photo 10: A 2019 Google Street View of the subject tree circled in red. The Norway spruce to the right is dead, and still standing with no signs of any structural failures.

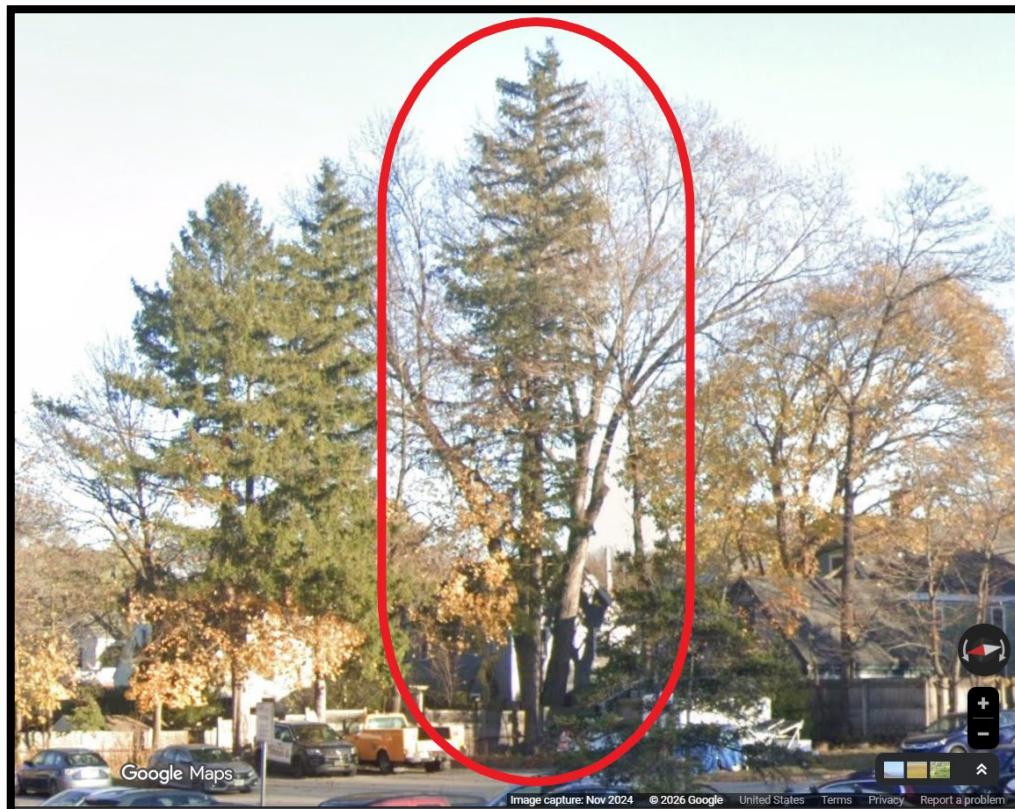
Photo 11: A 2024 Google Street View of the subject tree circled in red. The Norway spruce that was located on the right side of the subject tree has been removed.
