# **North and Union Railing**

**By Portsmouth Historic Cemetery Committee**

**November 6, 2025**

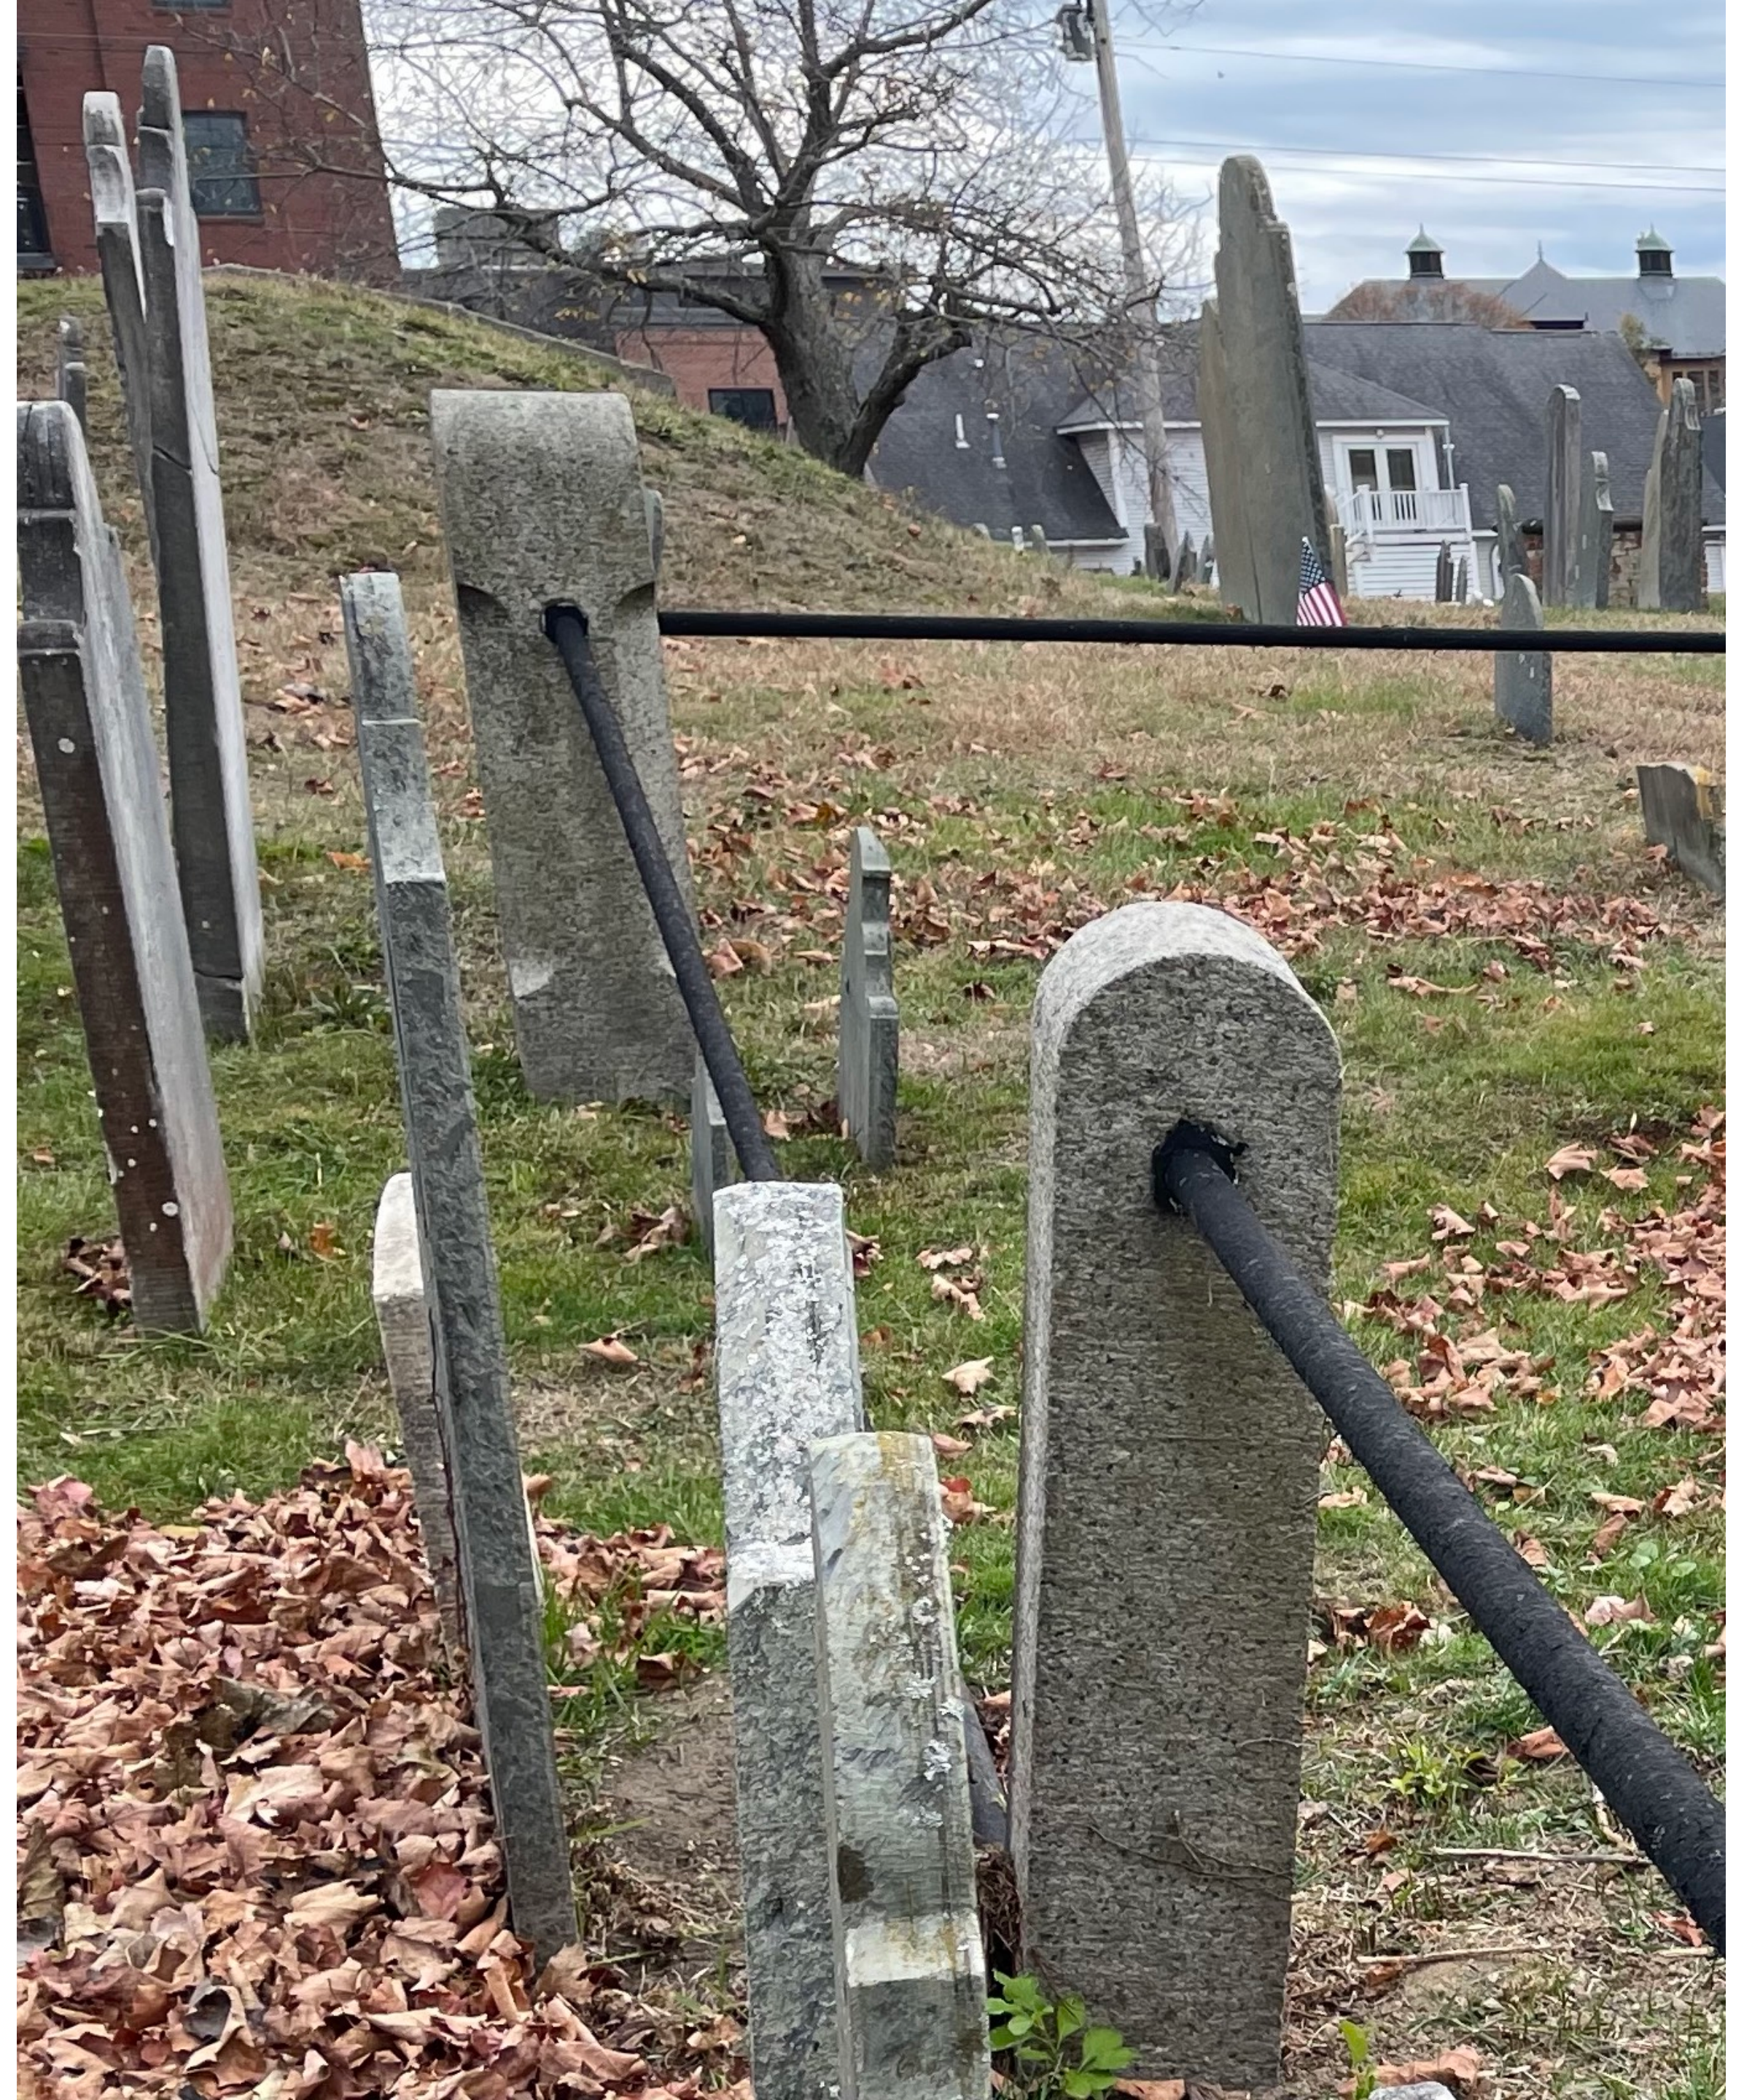
# North Cemetery Sheafe Plot

The railing in the backdrop  
needs to be lifted and secured  
to the post in the foreground.

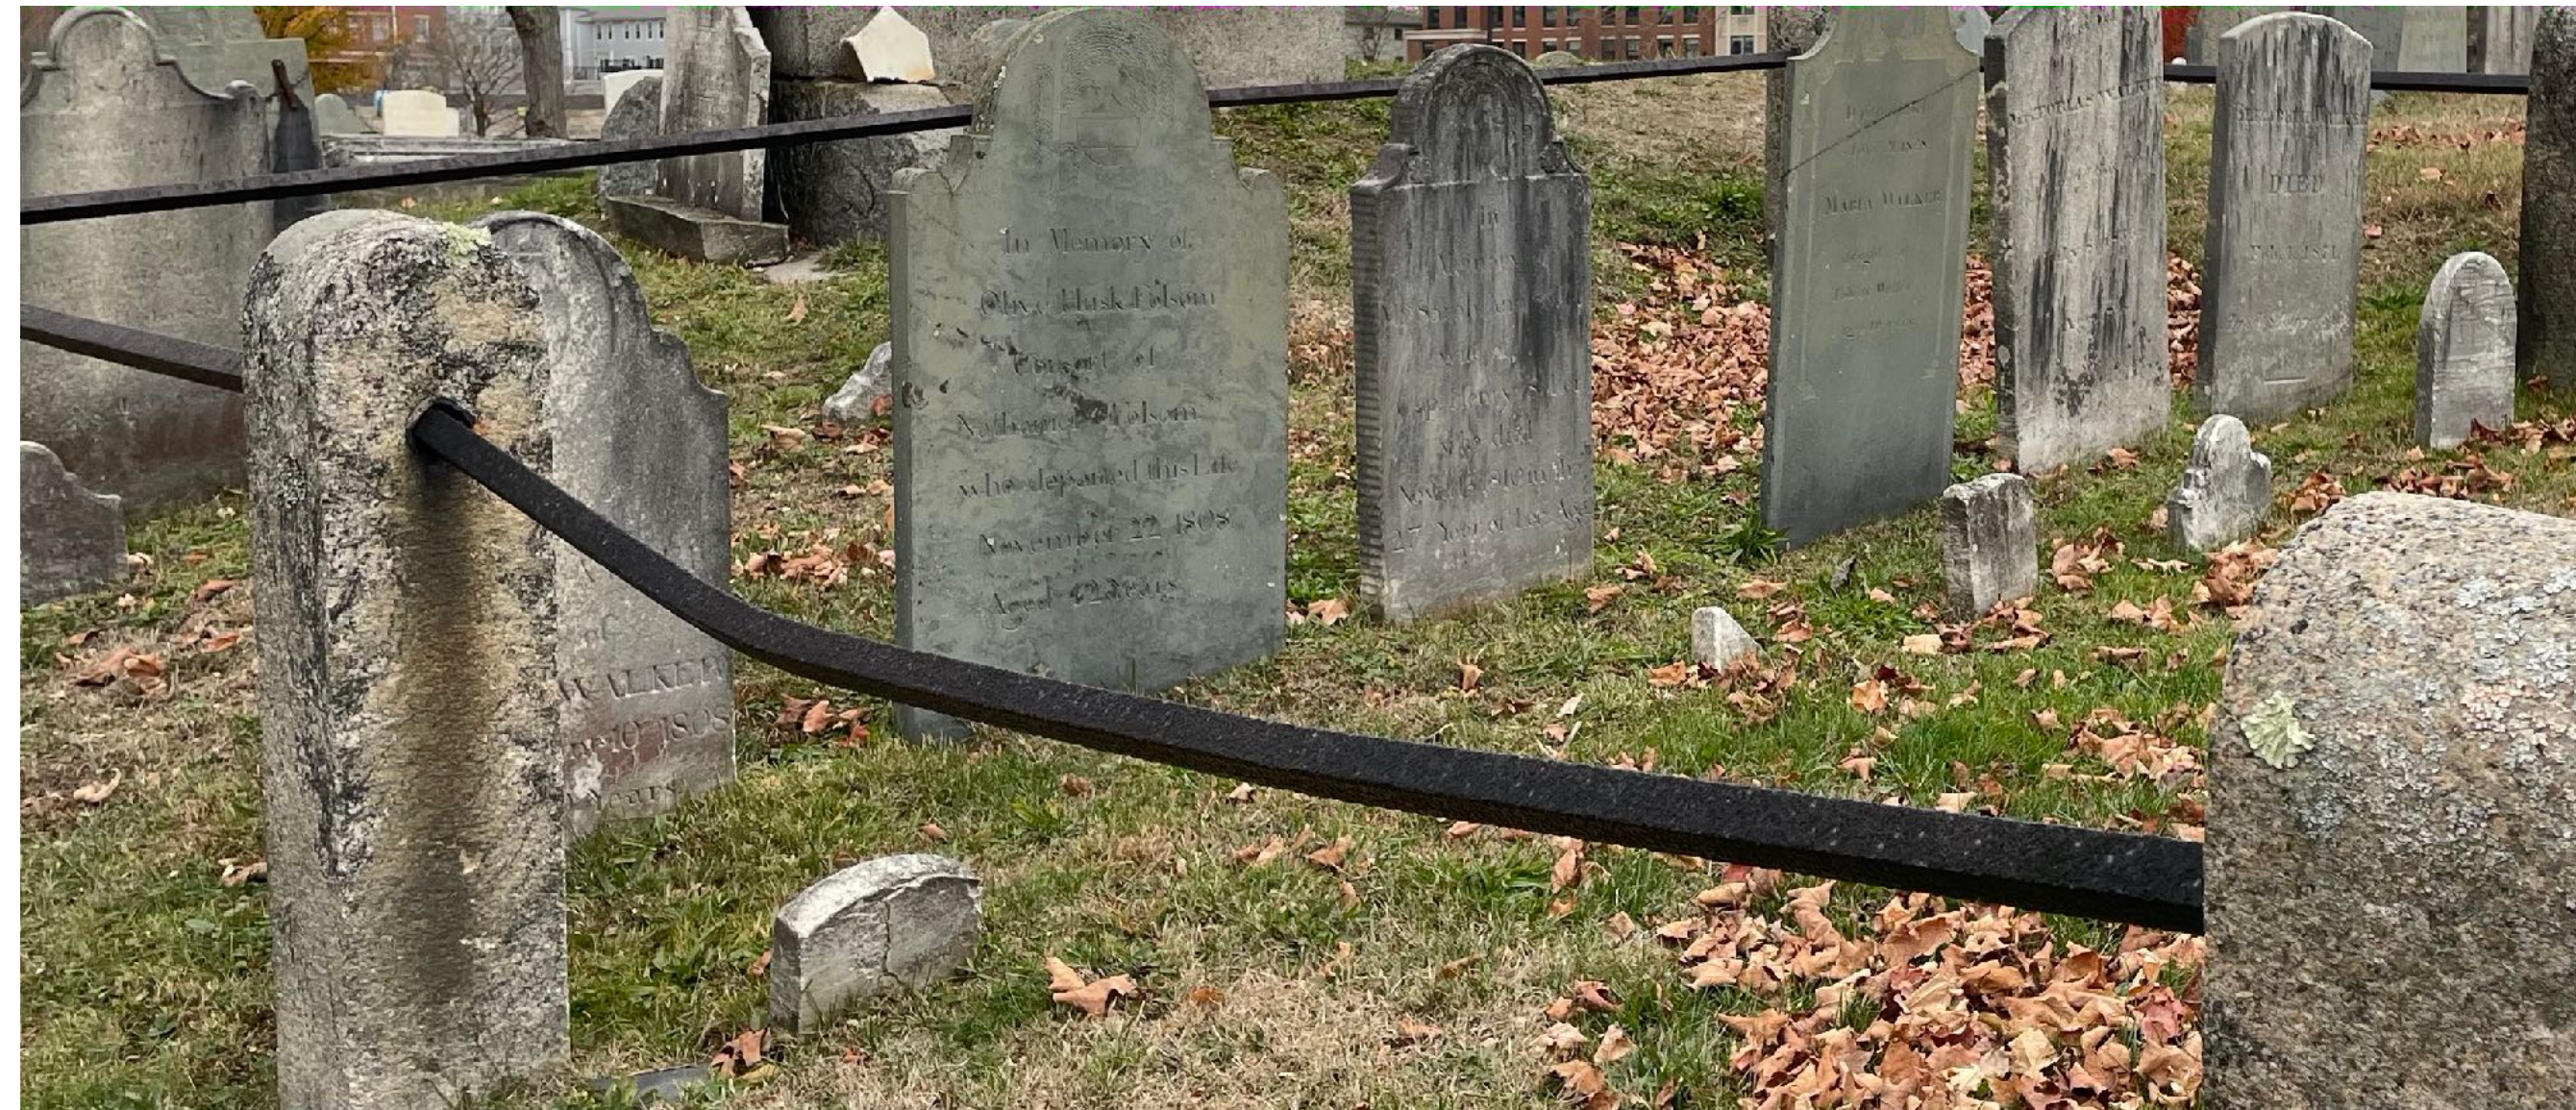
# North Cemetery Walker Plot

The railing is bent. Is it possible to straighten out?

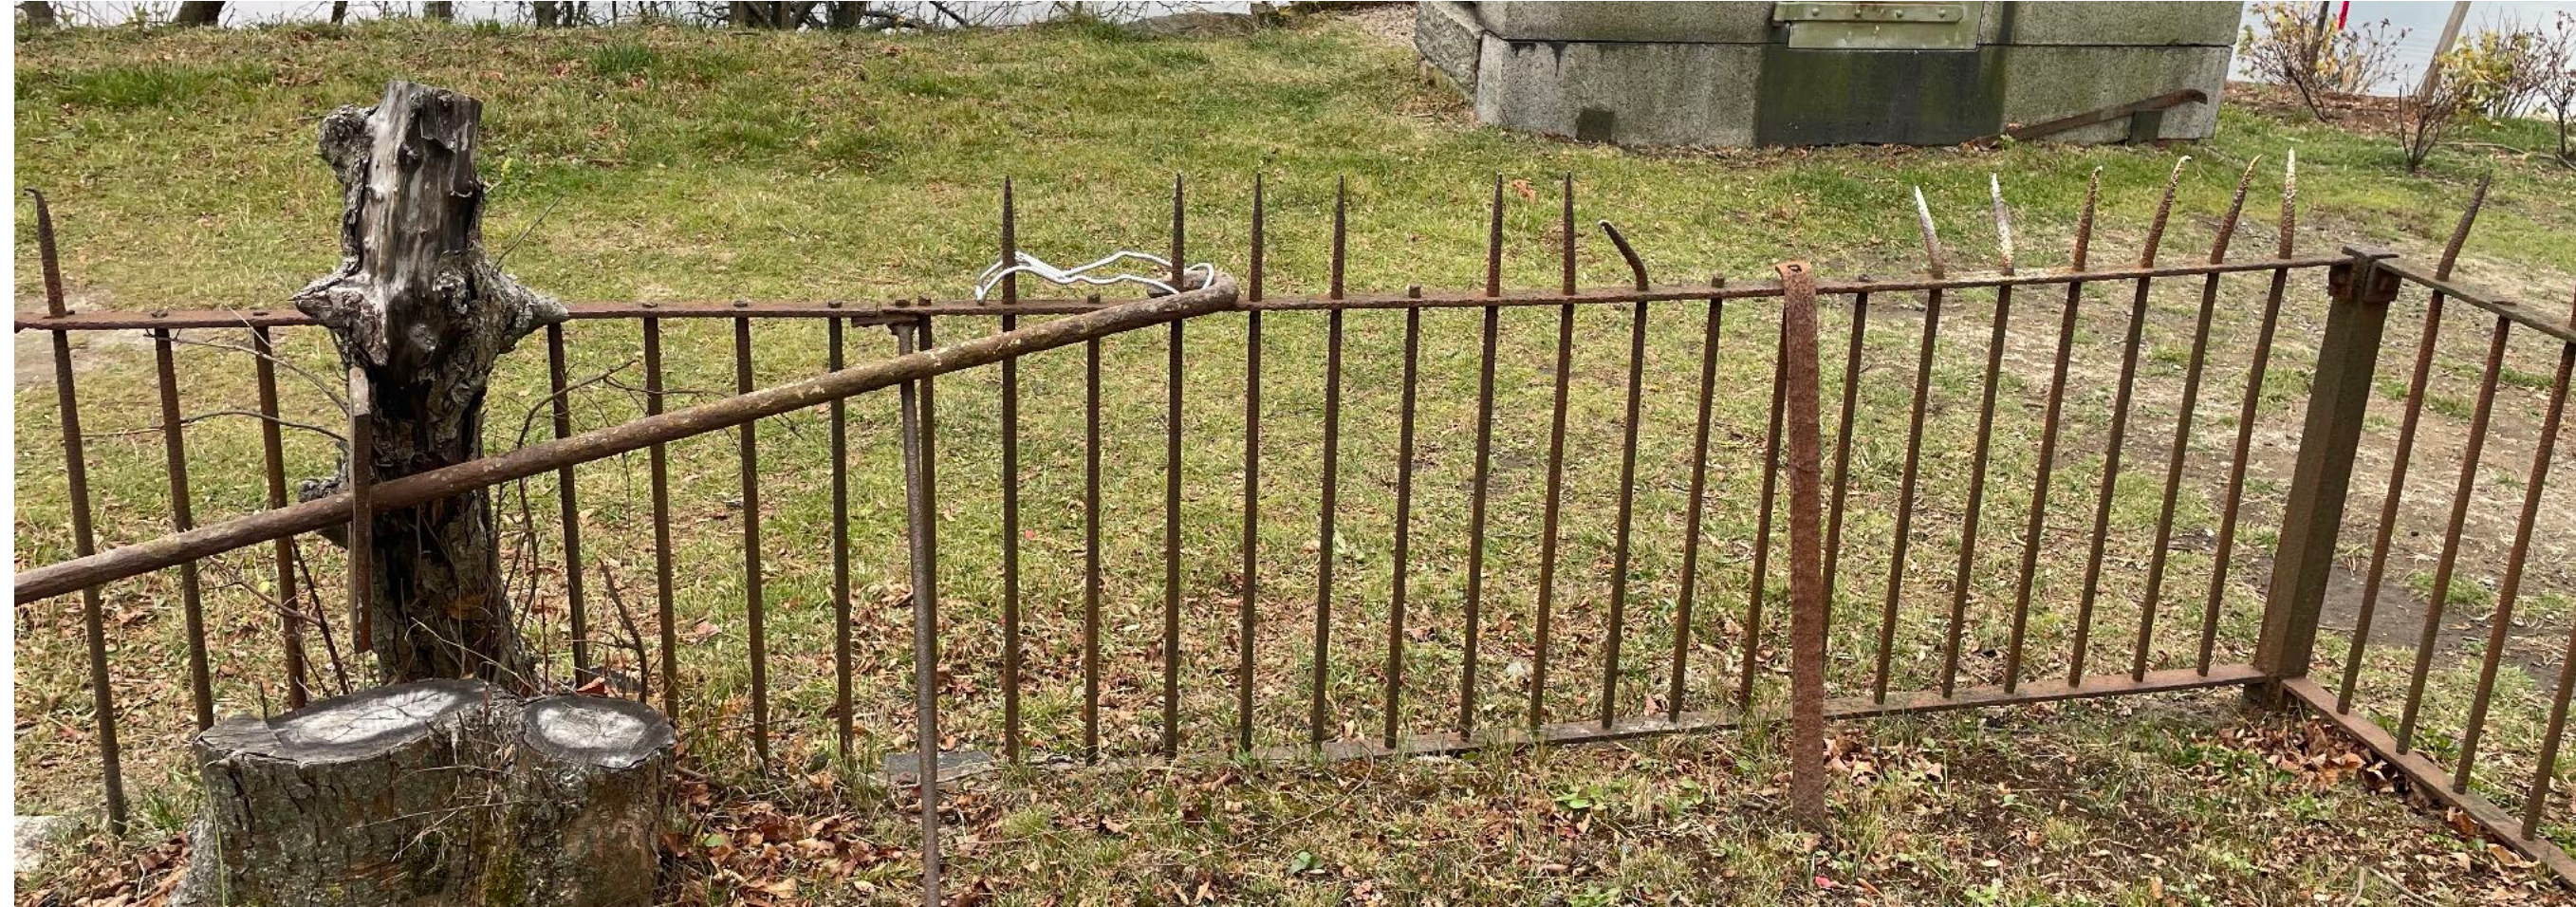
# Union Cemetery Missing Spirals

These two images show the top/spiral of the fencing is missing. The top photo shows several missing spirals and some that are bent.

Can the missing spirals be restored and the bent ones straightened out?

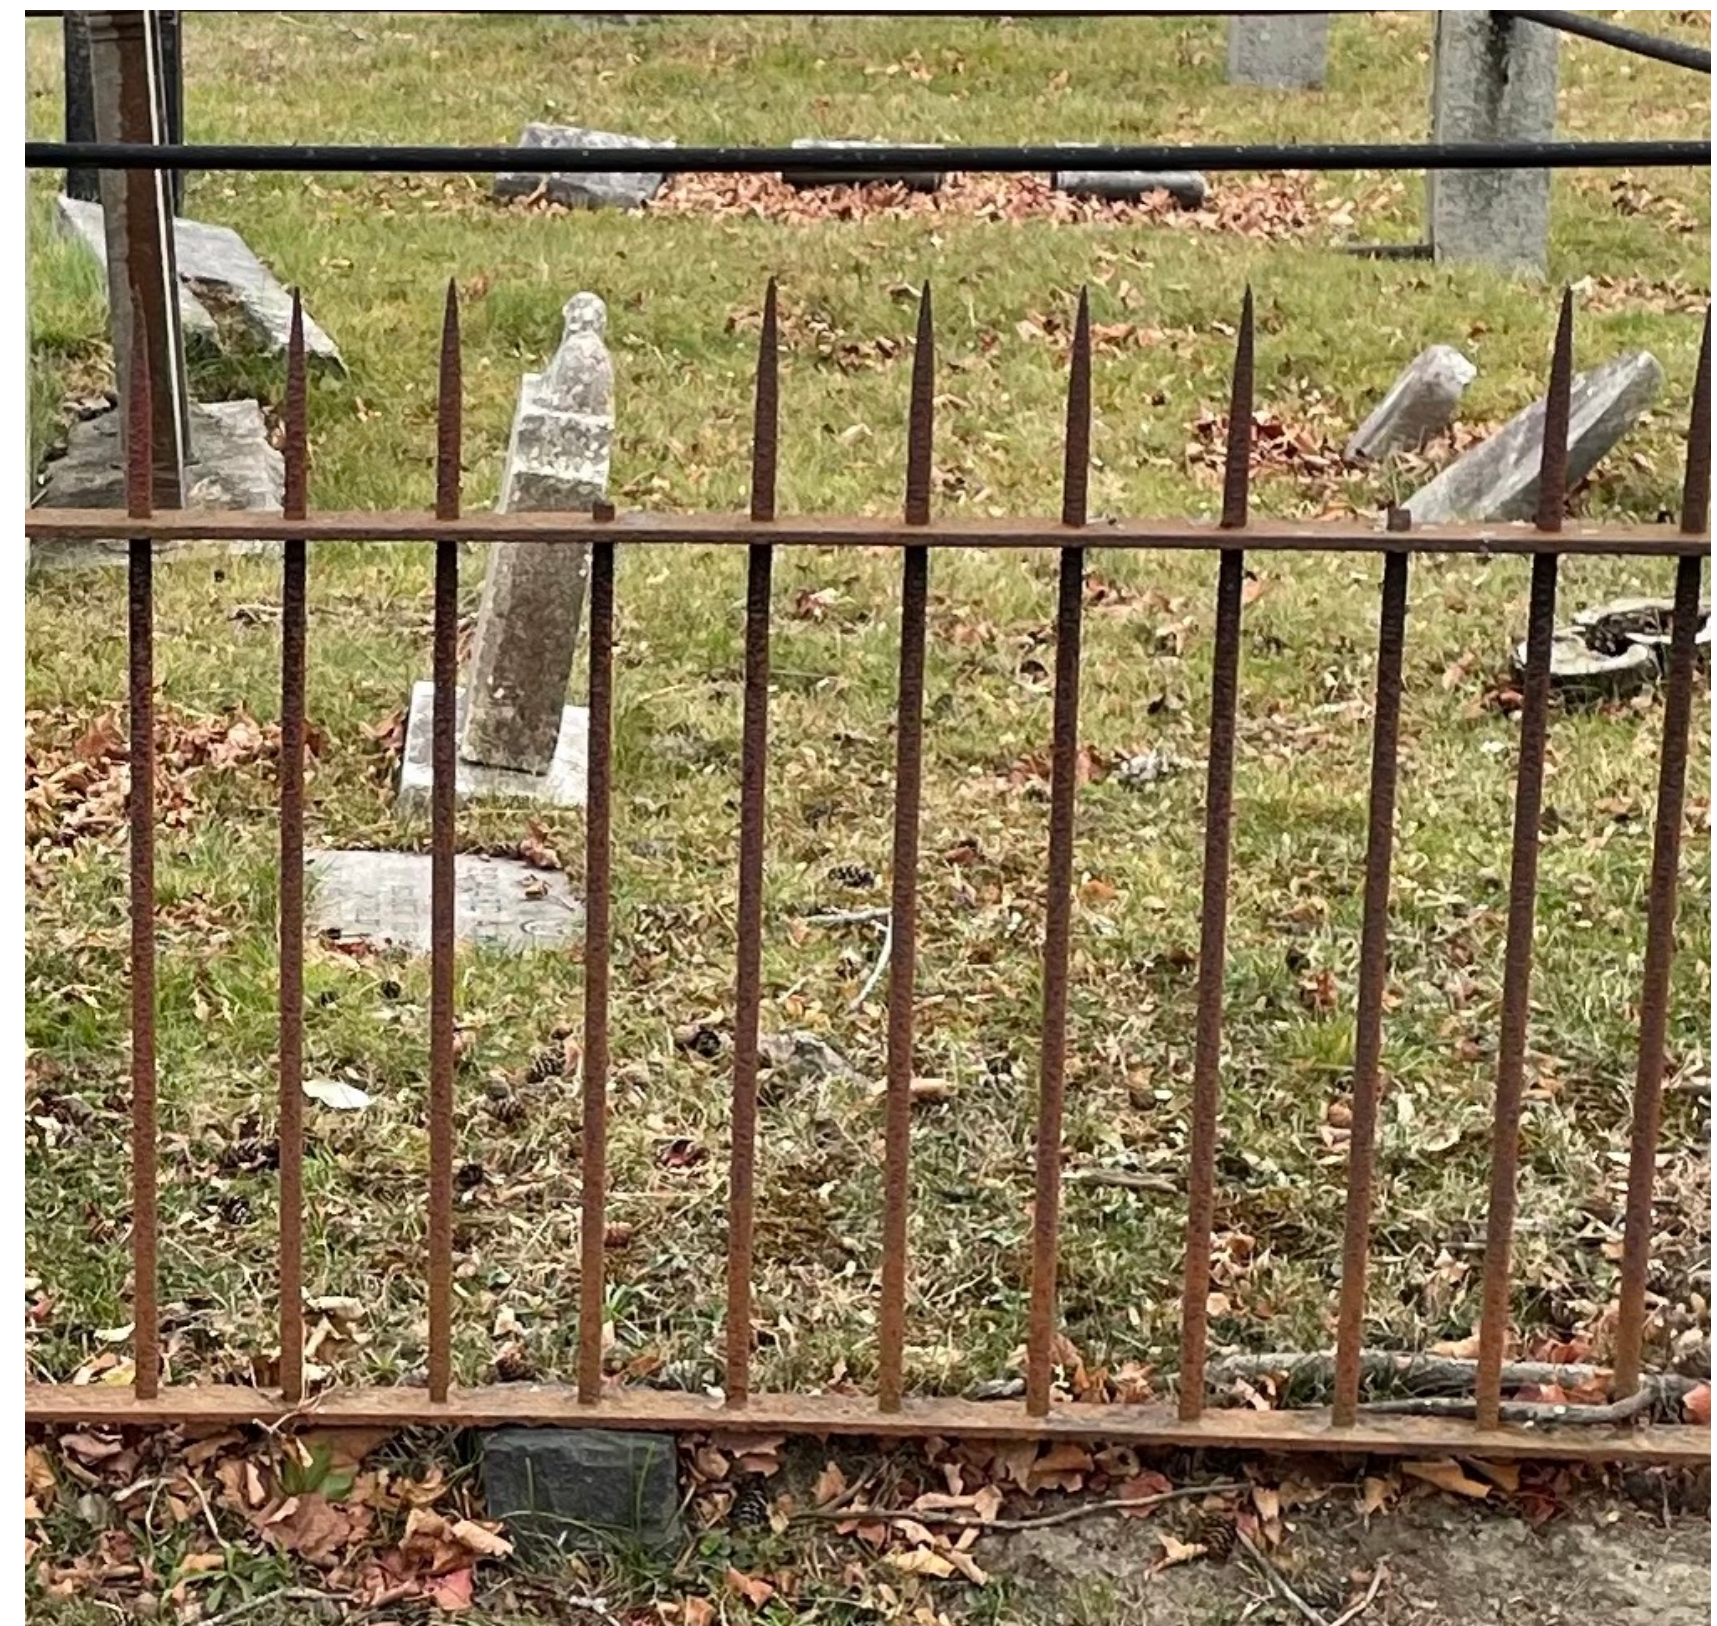
The bottom photo shows two missing spirals.

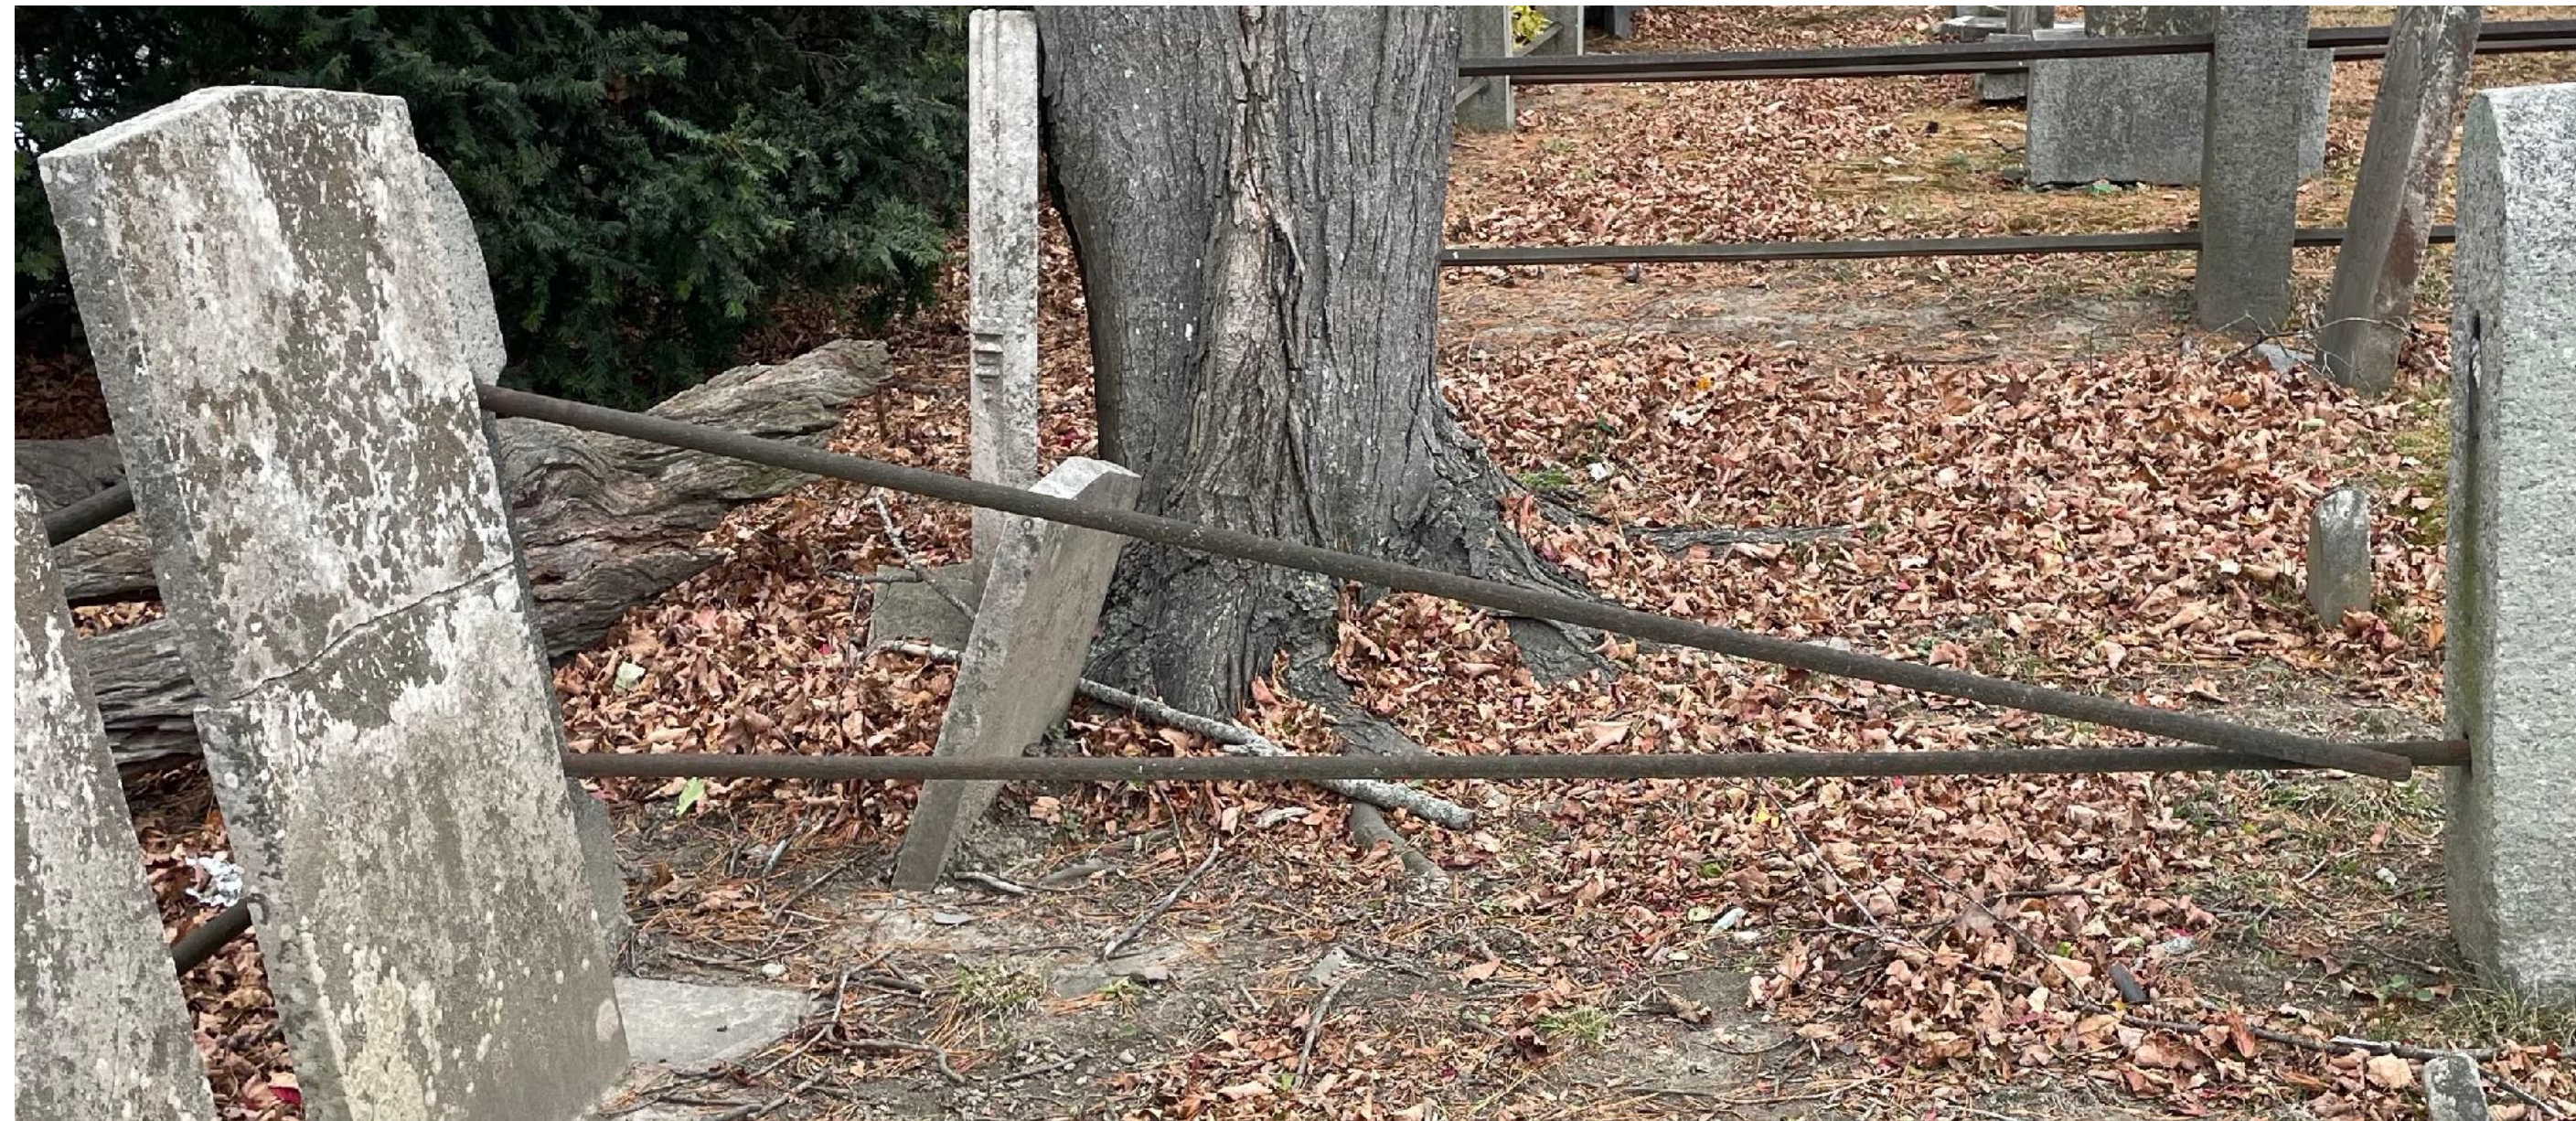
# Union Cemetery Unsecured Rail

The top railing in this photo lifts easily but needs to be secured to the cement post.

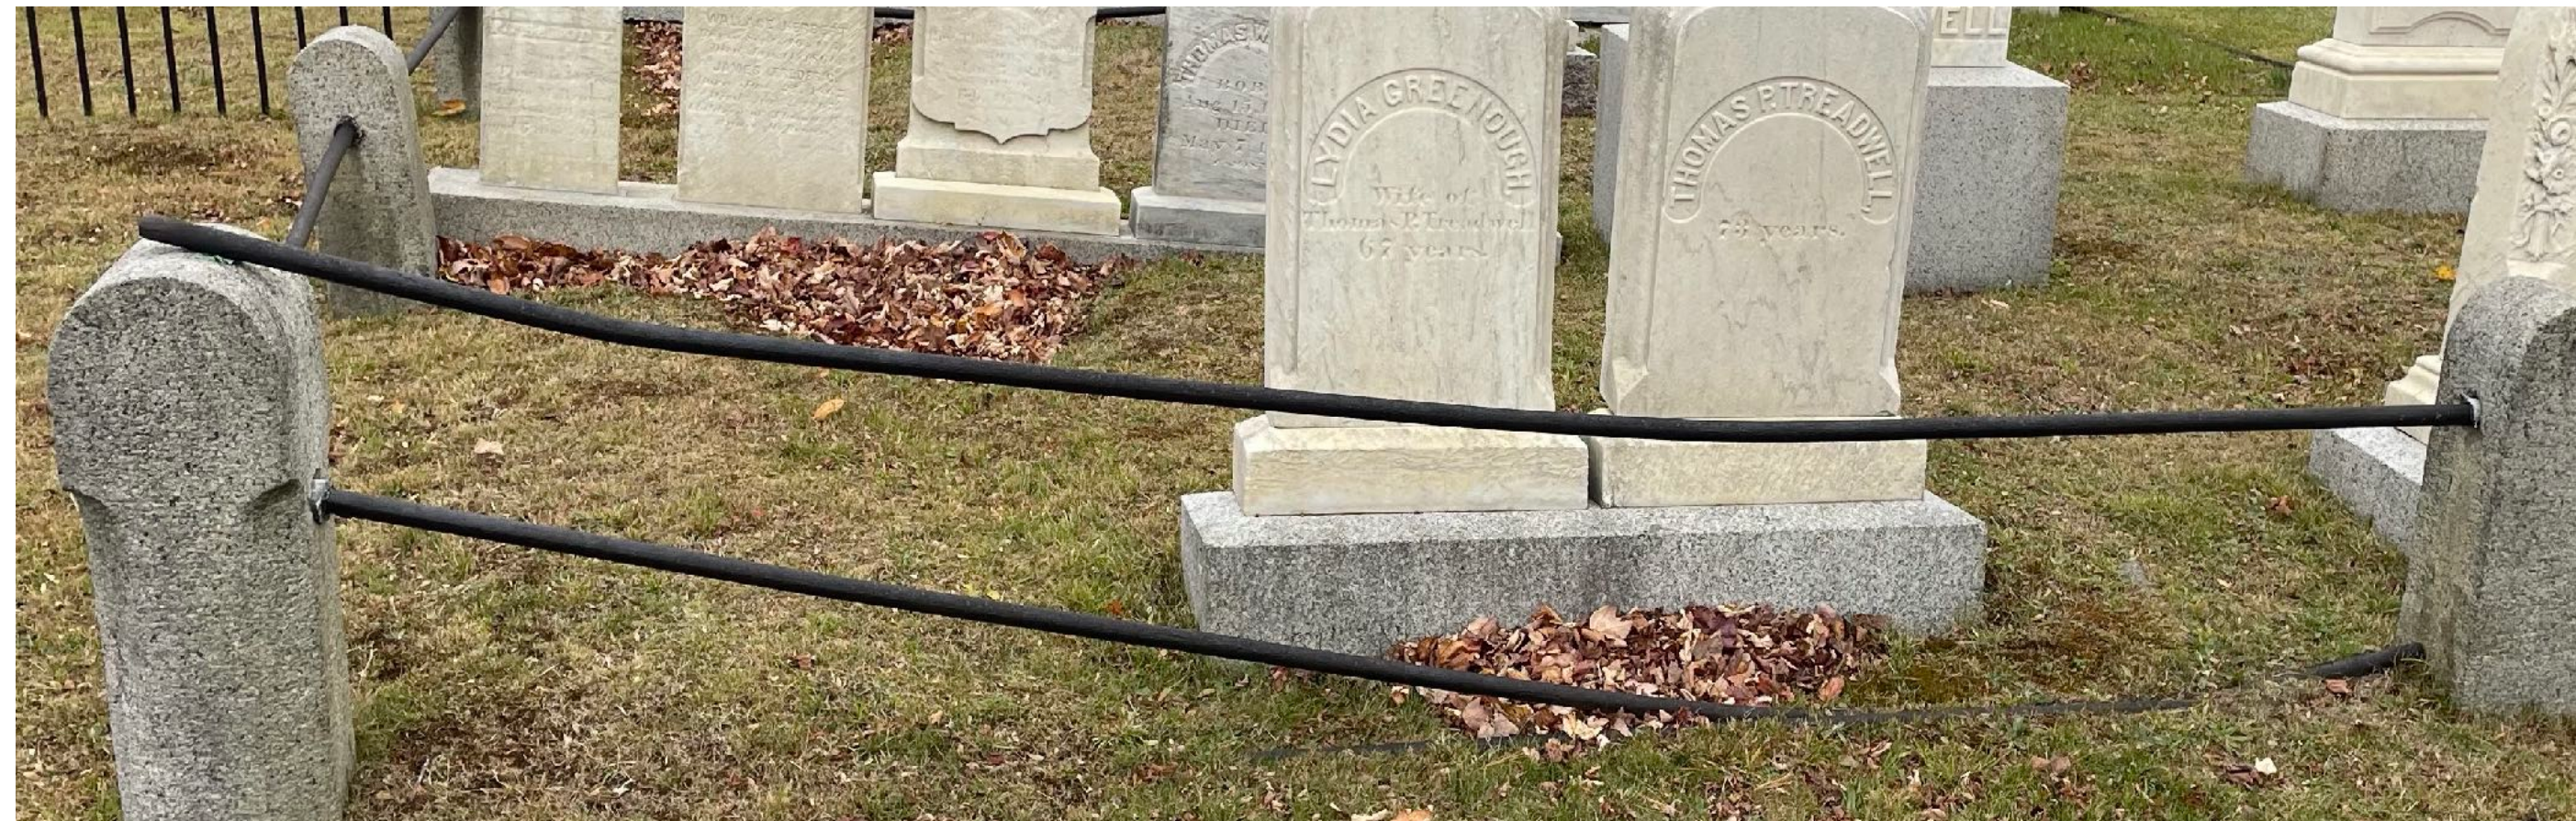
# Union Cemetery Underground Rail

The top railing in this photo is does not fit between posts.  
The bottom rail is buried and possibly on the right secured to the bottom when it should be secured to the top.

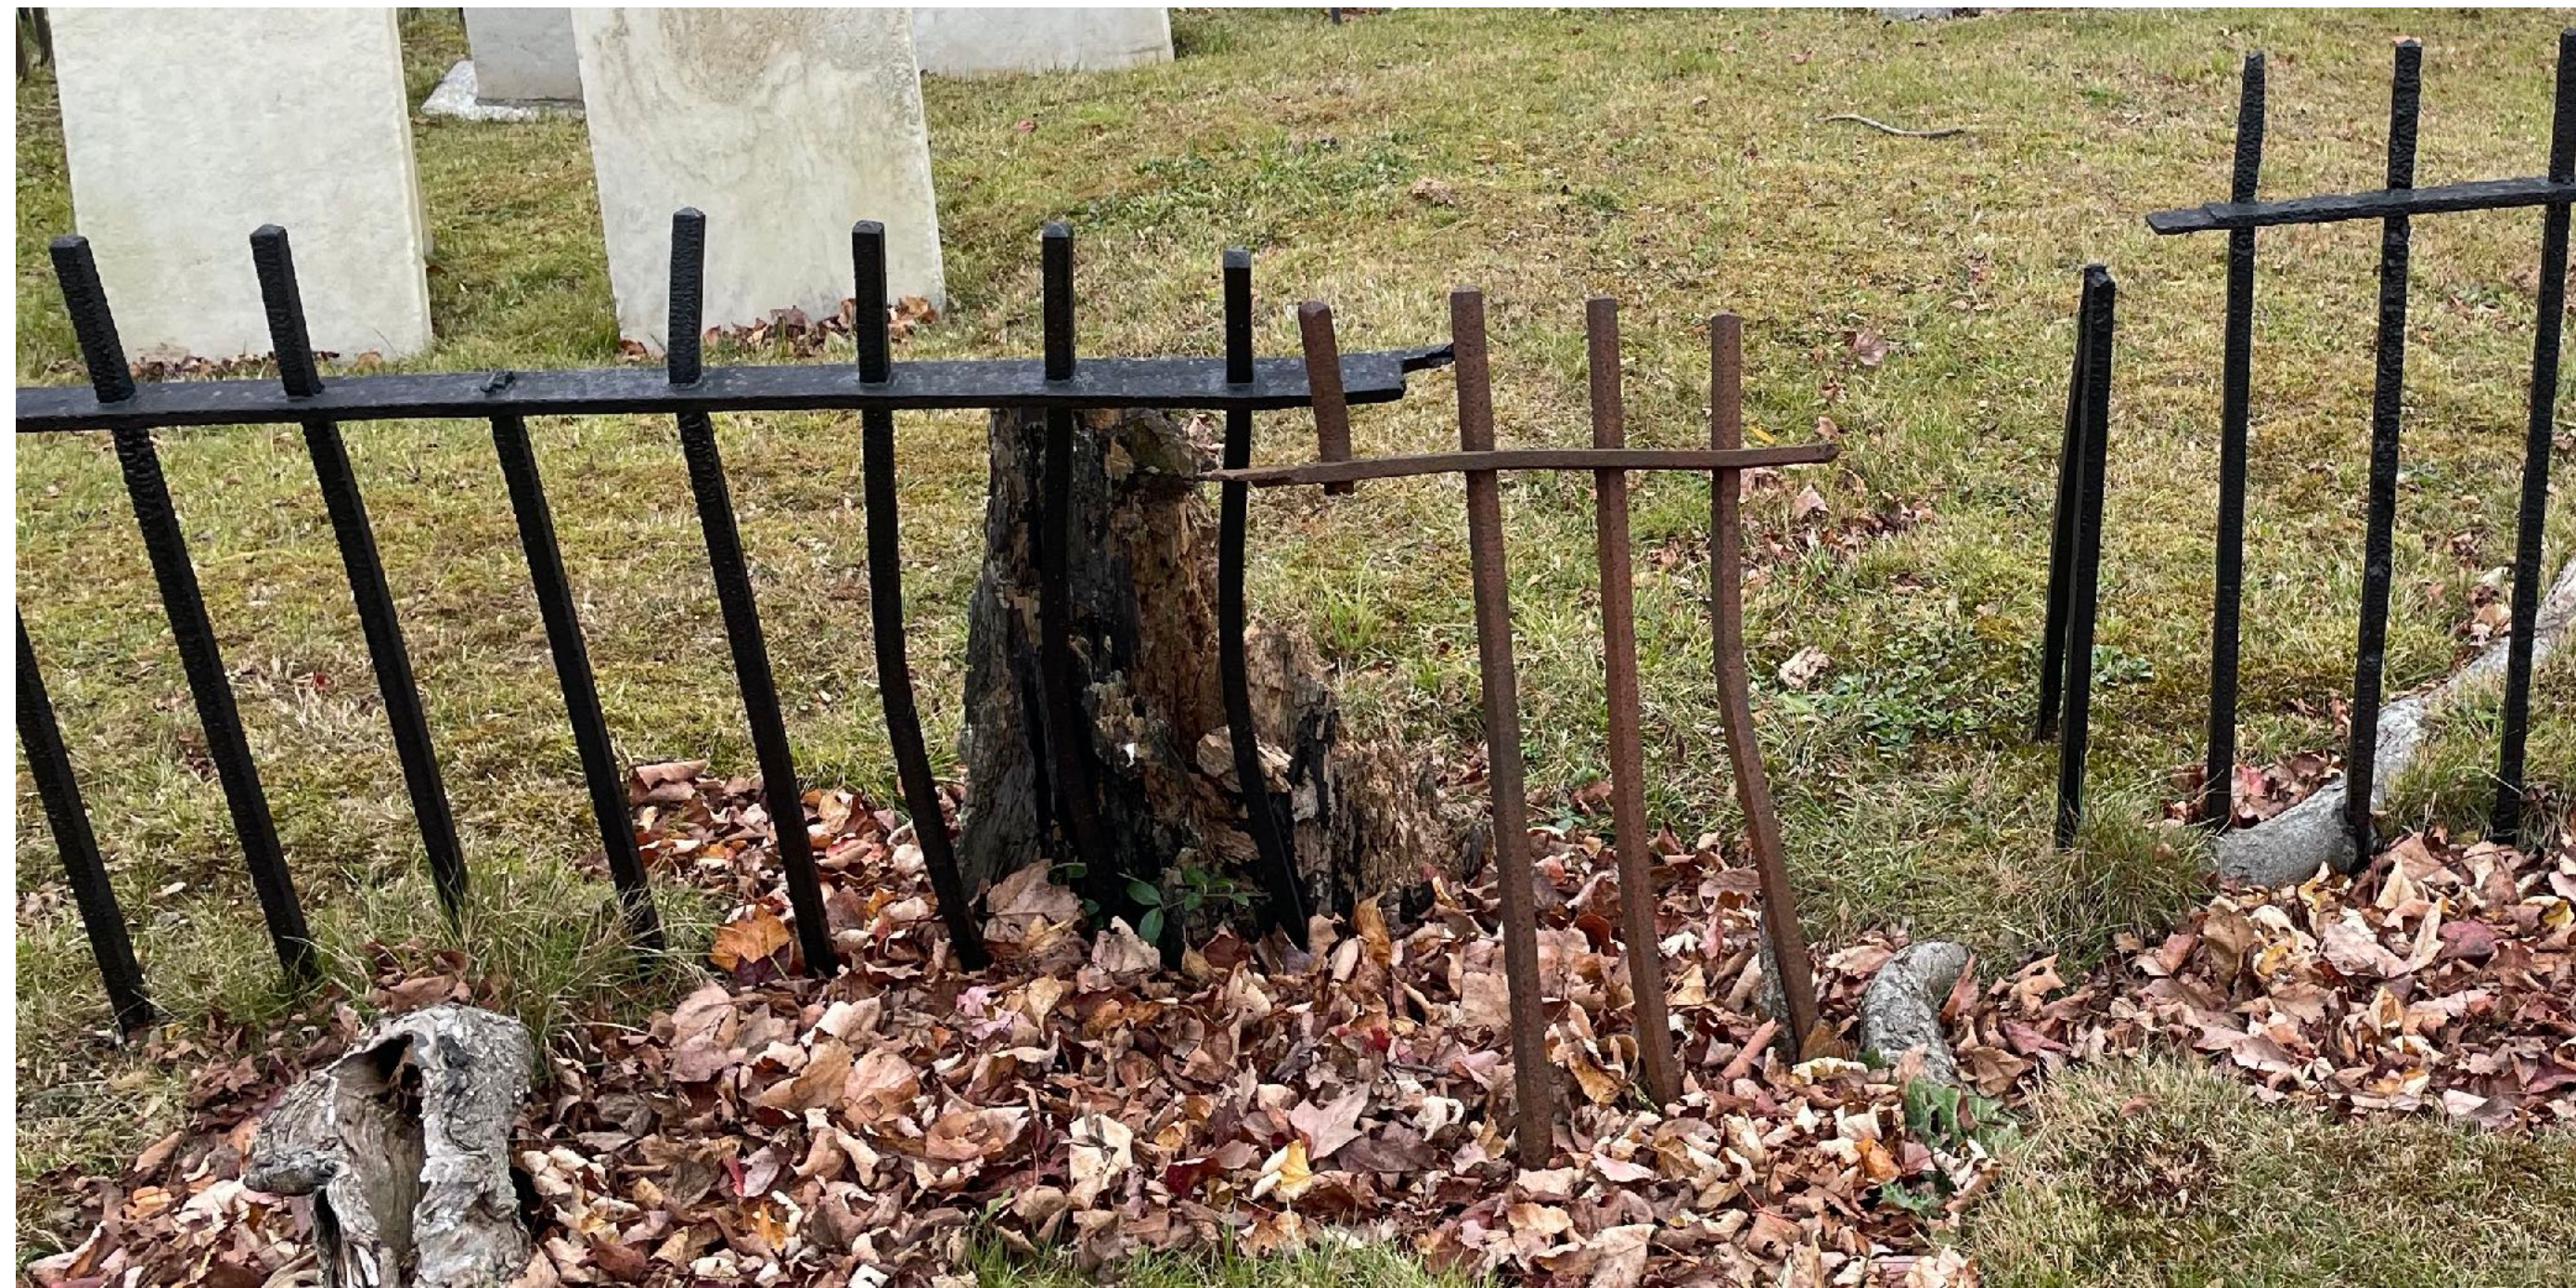
# Union Cemetery Broken Fence

A section of this fence is missing. Parts of the missing fence might be in the foreground but it is shorter than the missing piece. What would be the best approach to restore this?
