January 7, 2026

City of Portsmouth Tree Assessment

Portsmouth, NH City Hall
1 Junkins Ave,
Portsmouth, NH 03801

Timothy Bergquist
TimBer Property Consulting LLC
199 Holland Street
Moultonborough, NH 03254
(603)476-7118

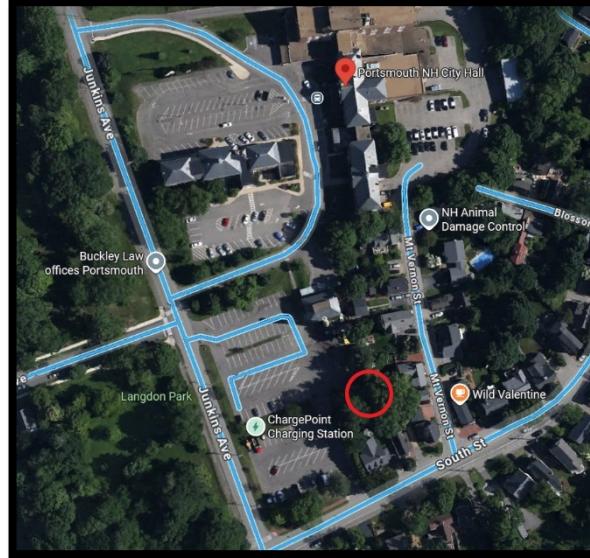
Photo 1: A Google Satellite map of the Portsmouth City Hall property, the red circle is where the subject tree is located.

The subject tree is a 21-inch (") Norway spruce, *Picea abies*, and is located South of the city hall, near the lower parking lot (Photos 1 & 2). The tree is located between the parking lot and a fence that separates the city property from the neighboring residential properties.
